Nurses Memorial Chapel Media Brief Update – 4th May 2018

Building History & Description

Summary of Works

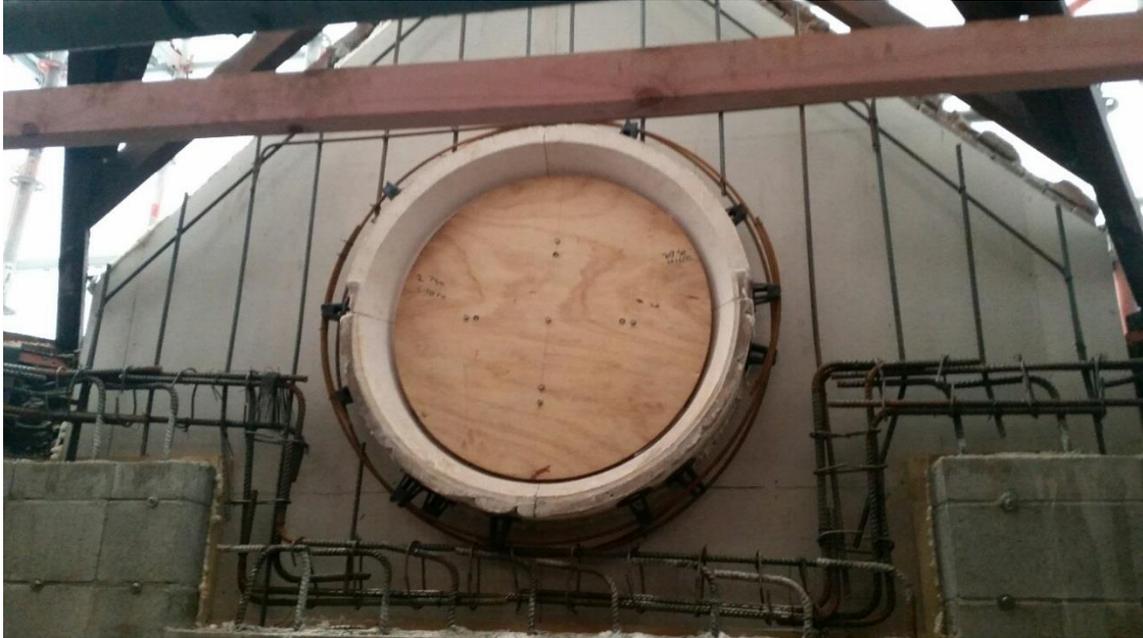
View of new reinforcing being installed to the round stained-glass window in the Chancel.

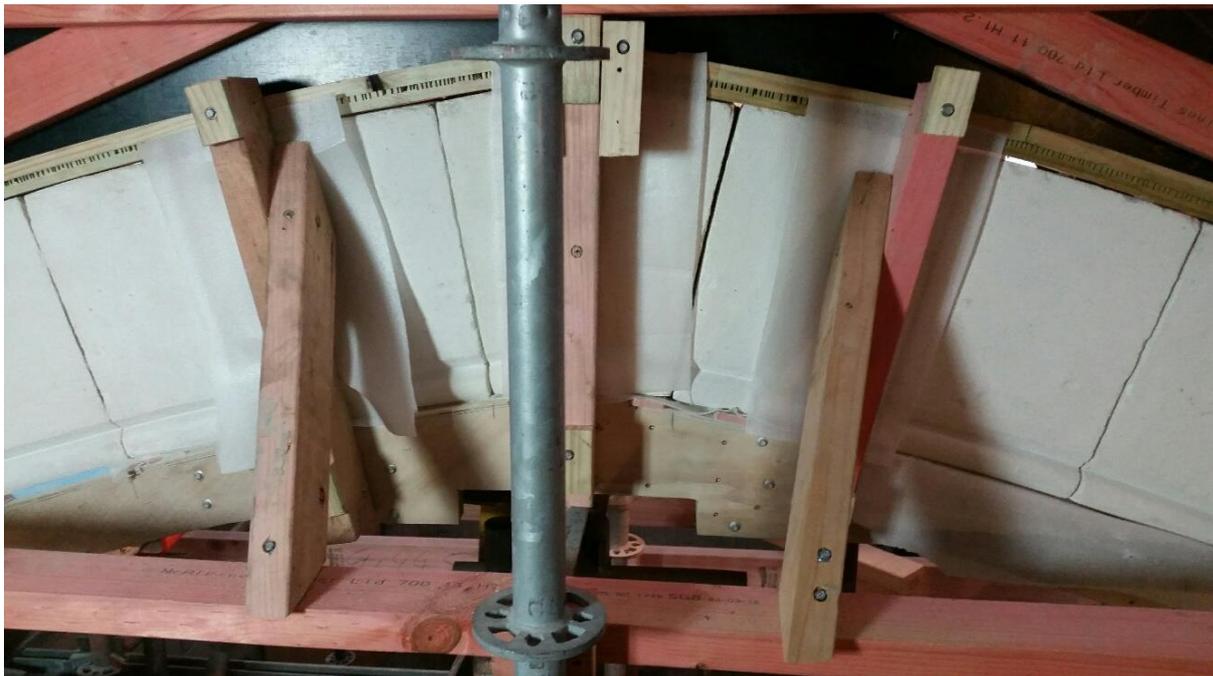
The reinstallation of the Oamaru Limestone Arch to the Chancel has now started. The existing stone was carefully deconstructed and has now been installed back to its original position.

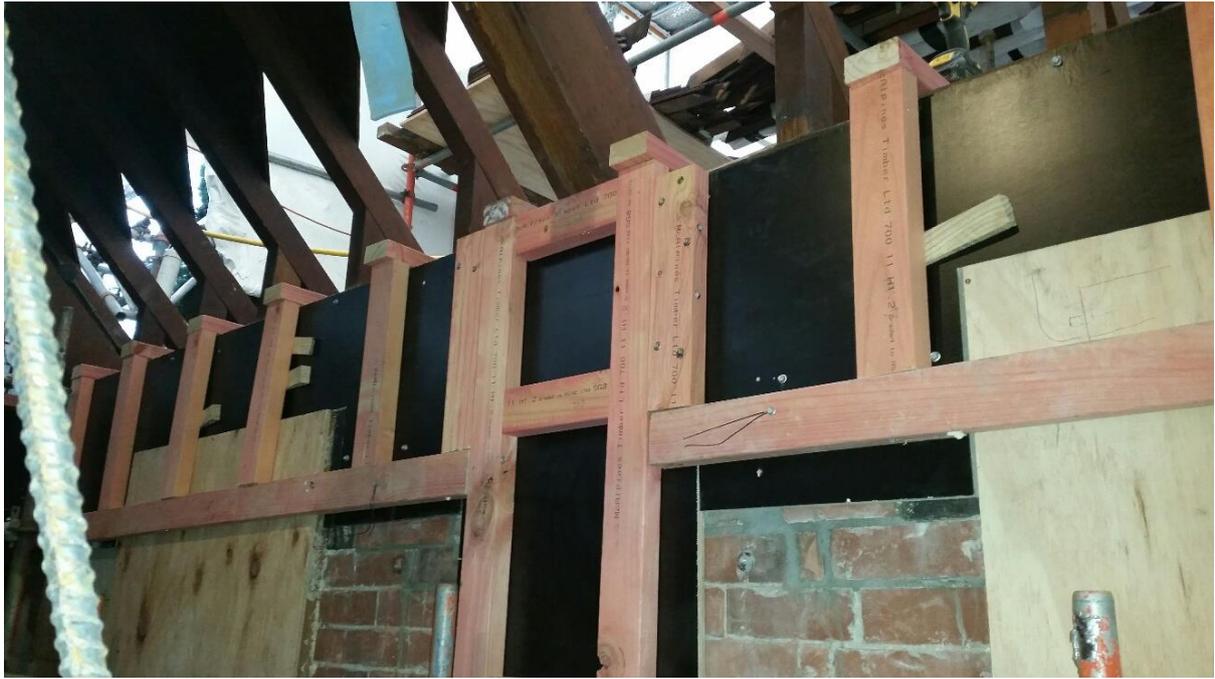
The black panels indicate the boxing to the vertical buttress columns and the horizontal ring beams at the time of the concrete pour to the nave areas. All reinforced concrete to the Nave has been completed.

- The inner columns to the Buttresses, the ring beam, Dormer ends have been poured and works to these areas completed.
- The gable end to the Nave has now been completed with RC.

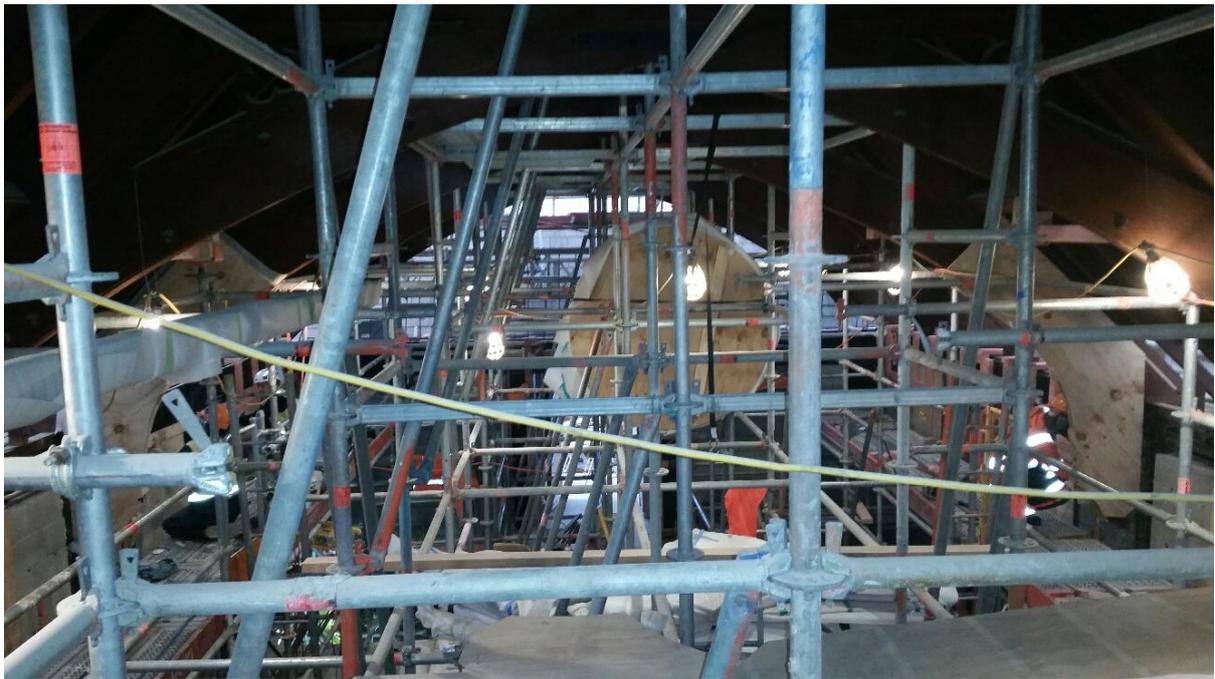
View of the Chapel Nave looking back towards the front entrance to the building. The scaffold propping has supported the roof independent of the building whilst the strengthening works have been completed. The propping will be removed the first week of May now that the building and roof are re-connected.

- Due to the remediation of the Asbestos and the loss of nine weeks from the construction programme, we have had to prop the entire roof to work on all aspects of the structure at the same time. Part of the propping, approximately 50% to the North end of the Nave has now been removed on the completion of the ring beam install.
